U.S. Highway 85 Corridor

Conditions Survey

Fountain, Colorado

Surveyed in September / October 2007 and April 2008

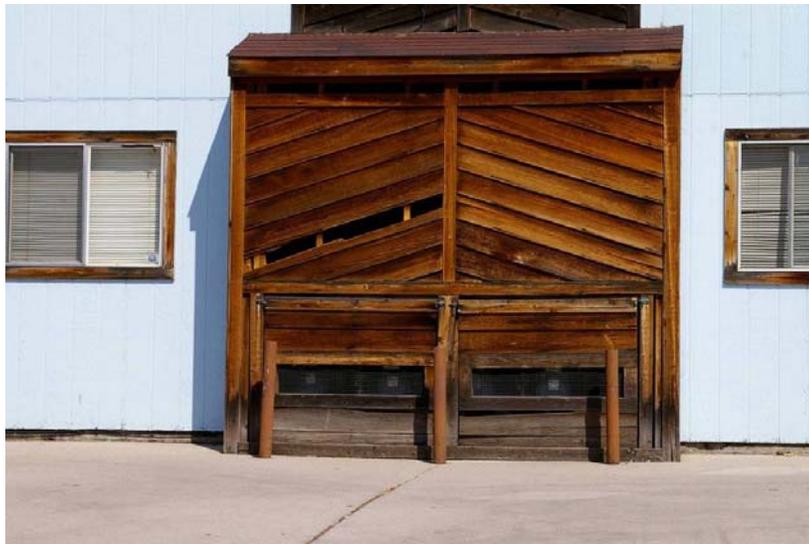
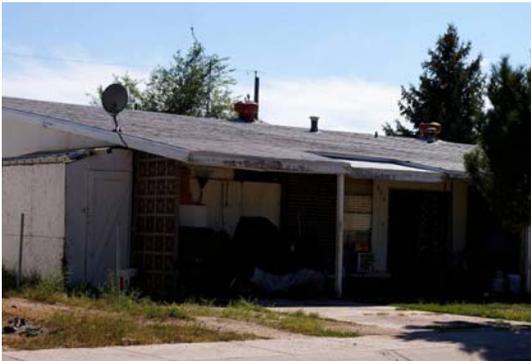
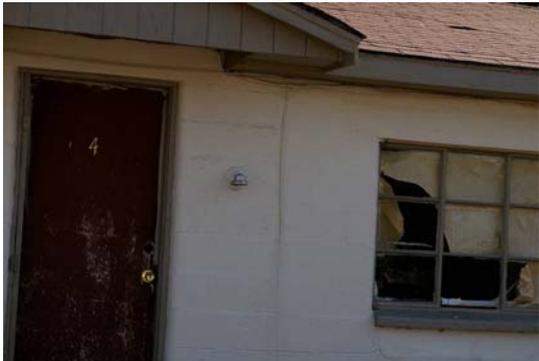
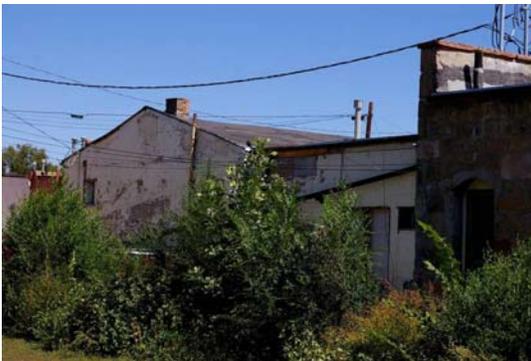
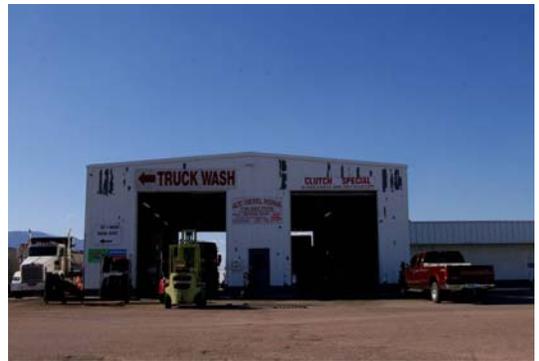
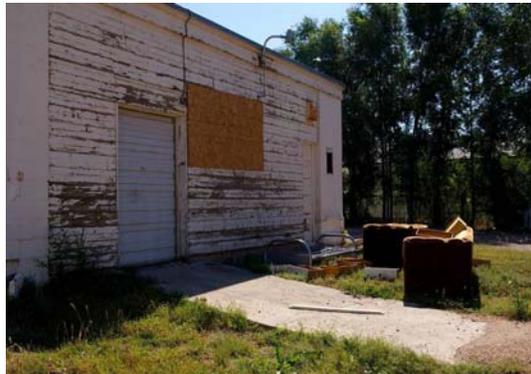
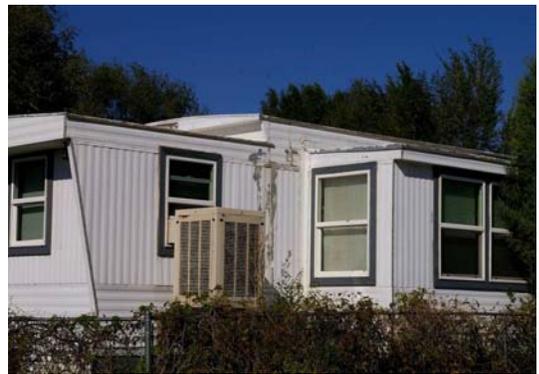
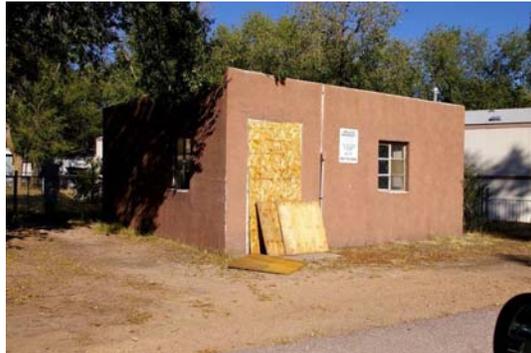
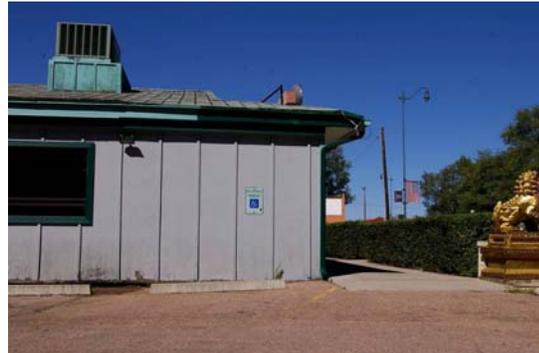
Examples of Condition (a): Slum, Deteriorated and Deteriorating Structures

The condition of structures in the Area varies considerably from -- visibly dilapidated older buildings (both occupied and unoccupied), to somewhat deteriorating, yet generally sound buildings, to well-maintained and even new structures. The shopping center at the north end of the Area is an example of buildings that appear sound externally, yet have a history of building defects and deterioration (including interior problems). A bowling alley in the area has deteriorating exterior surfaces, walls and loading areas. Apartments located to the south along Southmoor Drive exhibit signs of weathering on their external structures.

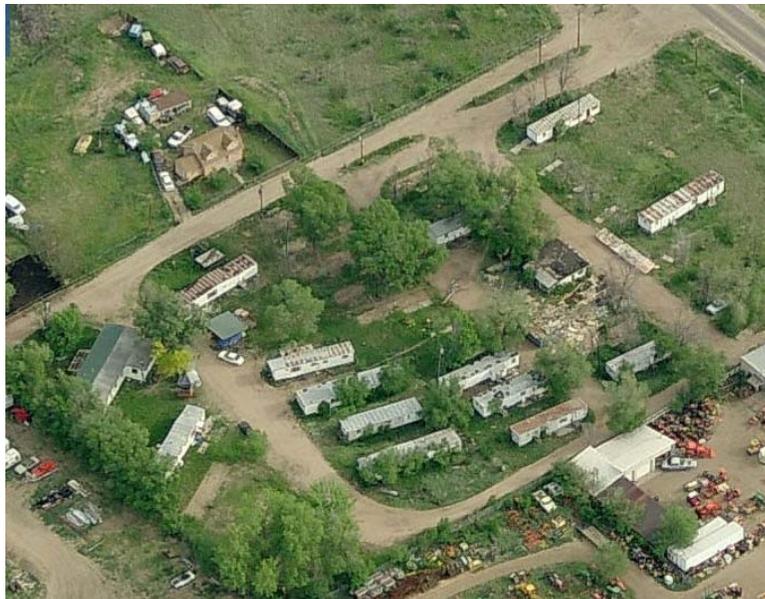
Further south, in the vicinity of Exit 132, there are examples of deteriorating roofs, wall, fascia, gutter/downspout, exterior finish, windows, doors, fences/gates and outbuildings. Deterioration is especially pronounced around the former location of Dick's Rock Shop and in the trailer park located on Southmoor Lane, shown below.

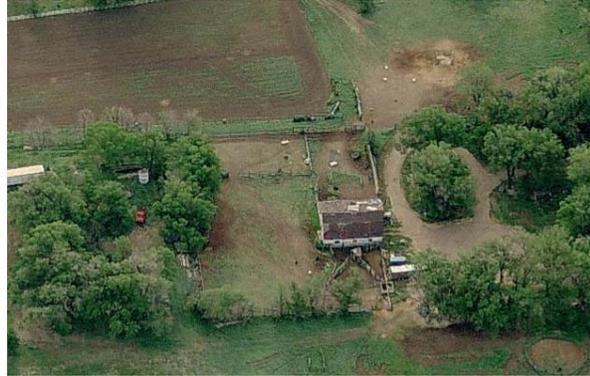
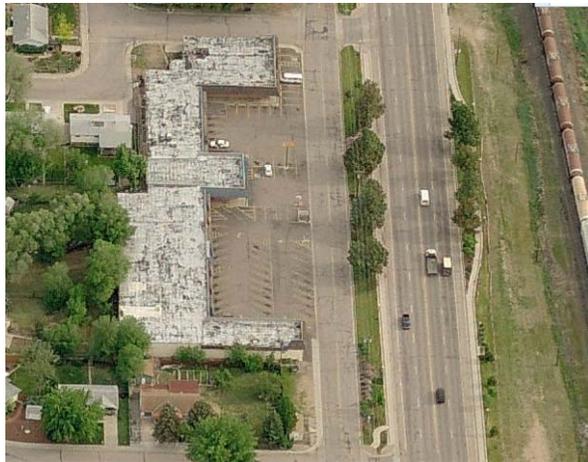
A farmhouse located in the southeast quadrant of Mesa Ridge Parkway and U.S. 85 (Block 11 on the maps in the Appendix) is also dilapidated, as shown in the image below.

Further south, in Survey Blocks 14 and 15, are two residences and storage/ salvage businesses with some structural deterioration, especially in their outbuildings. A strip shopping center in Survey Block 15 has roof and exterior surface deterioration, as shown here.

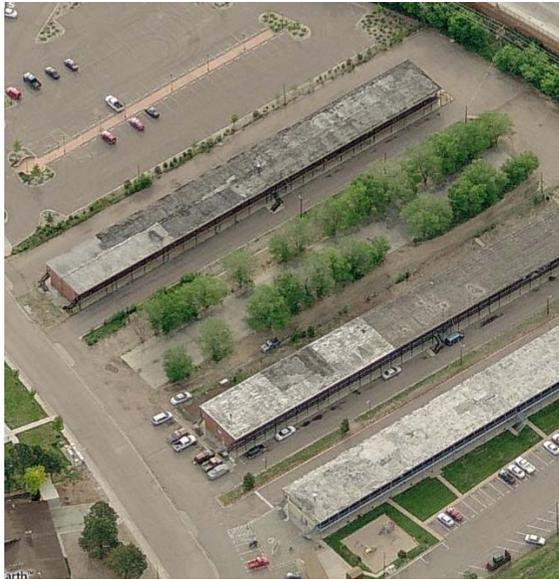
Most of the worst structural damage can be found west of Fountain Creek in the vicinity of Exit 128. Abandoned and semi-abandoned apartment buildings present the most pronounced slum-like conditions, however many trailer homes

in the area are also quite deteriorated. Ironically, a pocket of well-maintained modest single-family homes is located in the area (Survey Blocks 43, 44 and 46) surrounded by some of the worst conditions in the Survey Area. East of U.S. 85, several commercial structures and outbuildings show evidence of deterioration.

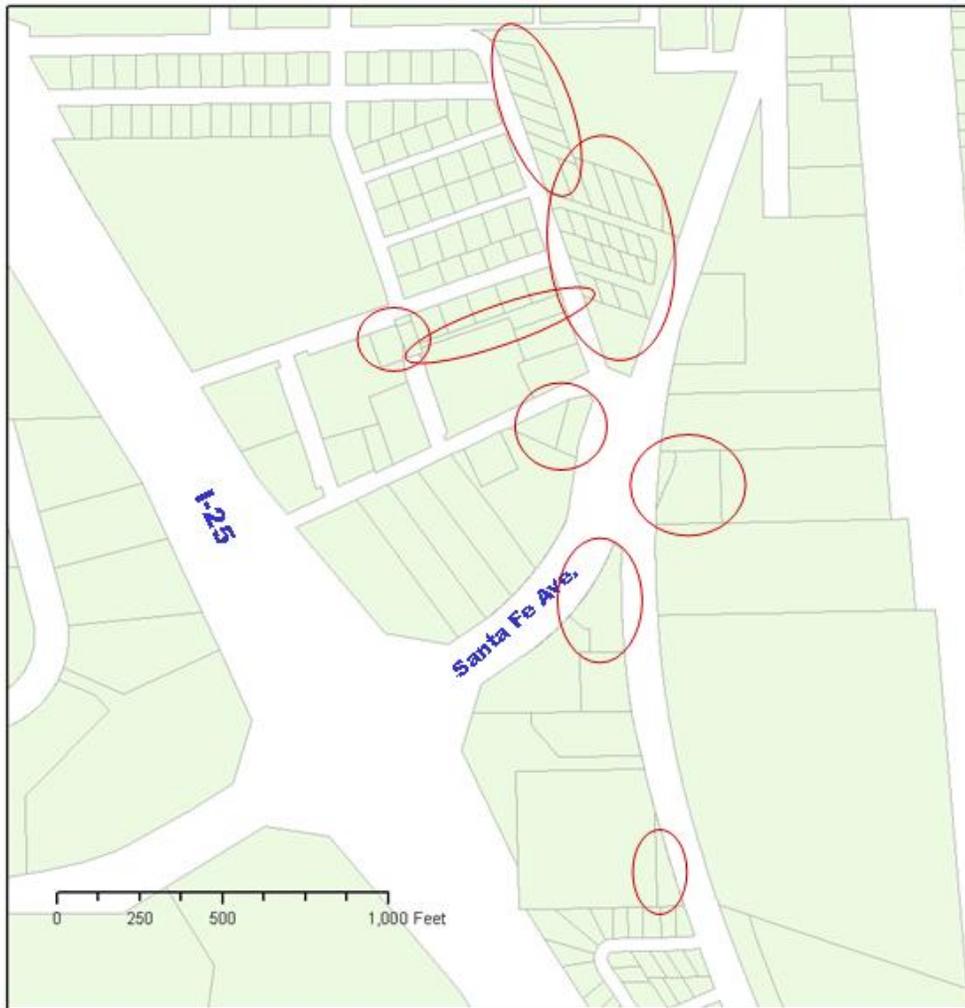
Examples of Condition (C): Faulty Lot Layout

due to inadequate vehicular access, also have a faulty lot layout, since adequate access is a necessary condition of adequate lot layout. Parcel shape and size are also affected by the many intersecting linear features in the Area, resulting in lots too small to be considered for redevelopment in today's market. Triangular and other oddly-shaped lots that are less conducive to sound development can also be found.

Although lots Downtown are generally small, they are appropriate in the context of surrounding uses and, therefore, generally considered redevelopable. The parcels west of I-25, while not in a platted grid, are generally well suited to highway-oriented development. Most of the other survey block areas, however, include lots that suffer from difficult-to-develop conditions of size, shape, layout and / or accessibility.

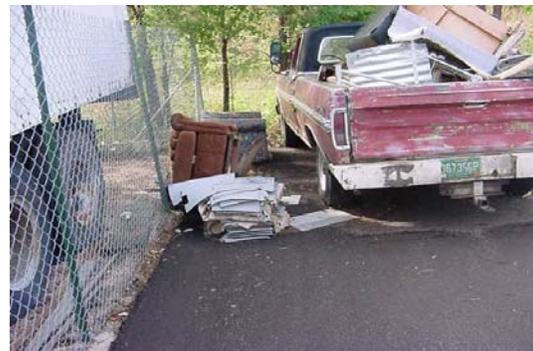
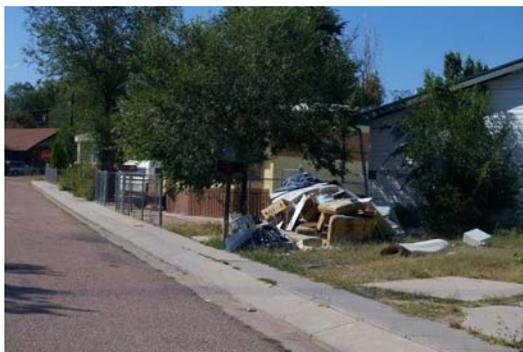
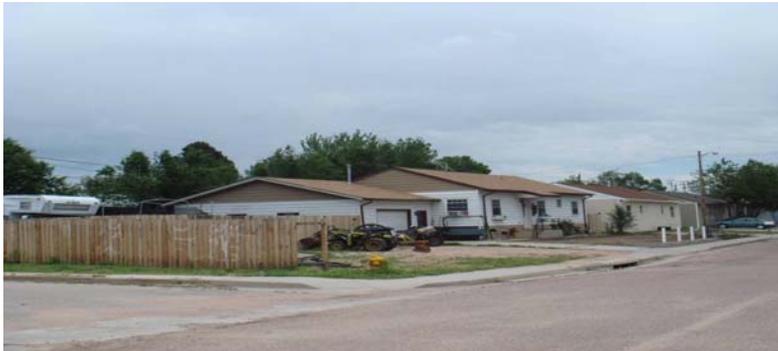
Deterioration of Site and Other Improvements (Condition E) is a condition that generally follows the geographical distribution of *Deteriorated Structures (Condition A)*. Some survey blocks without structures may also have conditions of site

deterioration if there is dumping, excessive litter or weeds, or other general site neglect. Many properties in the Survey Area suffer from deteriorating parking surfaces. Others have a lack of landscaping (in areas where landscaping would be required or expected of new development). The photographs below show some of the more pronounced instances of site deterioration and neglect.

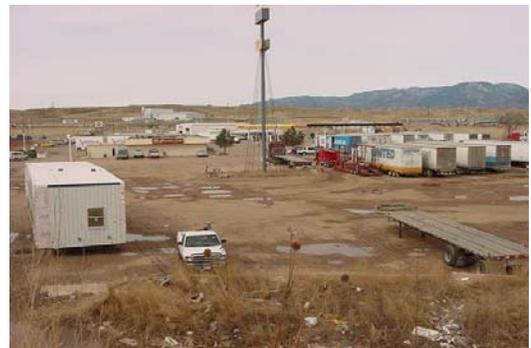
east of Exit 128, but street pavement deterioration can be found on survey blocks throughout the Area, including portions of U.S. 85 itself. Curb and gutter deterioration, shown in the photo below, can be found throughout the Survey Area. Inadequate storm drainage is a problem on some Survey Area parcels, particularly on Survey Block 66. Although newer sidewalks can be found in portions of Downtown, most of the Survey Area lacks well-maintained sidewalks. The most prevalent factor related to inadequate public improvements is overhead utilities, affecting almost all parcels in the Area.

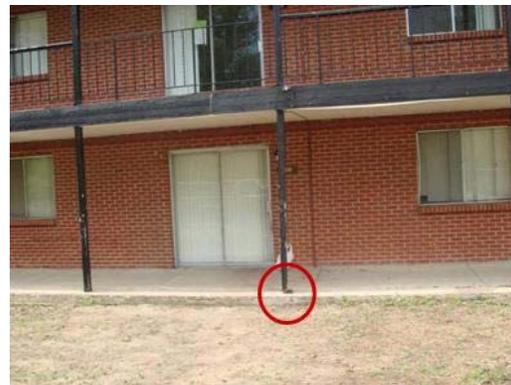
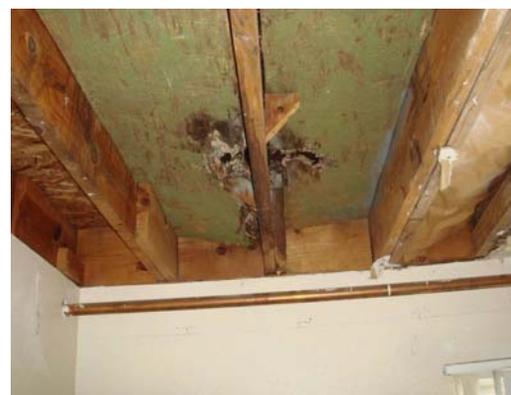
Unhealthy or Unsafe Buildings Conditions (Condition I) are similar to those found under the category *Existence of Conditions that Endanger Life or Property by Fire or Other Causes* (Condition H), and relates specifically to factors of design and construction of buildings that impact their safety. Fire safety problems are reflected in this condition, as well as Condition H.

Fire safety issues, primarily including lack of sprinklers and design /maintenance concerns for units within Area trailer parks, as discussed in the previous subsection, are noted in 46 survey blocks within the Area.

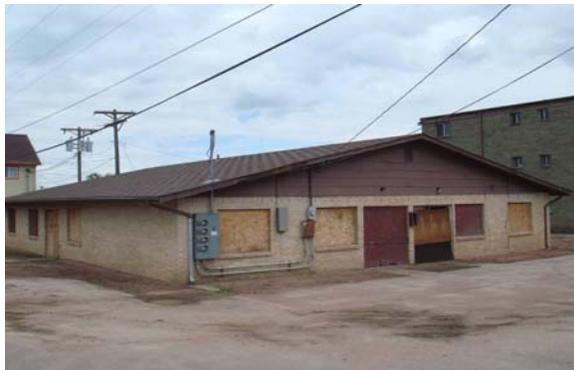
Vacant buildings are more prevalent in the area around Exit 128 area but can be found elsewhere in the Survey Area as illustrated in the maps and documented spreadsheet in the Appendix.
