CHAPTER 1 - INTRODUCTION

PROJECT BACKGROUND:

Design Edge, PC completed a **Facilities Needs Assessment Study** in 2008 for the Utility and Public Works Department, to specifically study the Utilities and Public Works Department current facilities needs, and provide the city a roadmap for future growth in five, ten, and twenty year planning horizons.

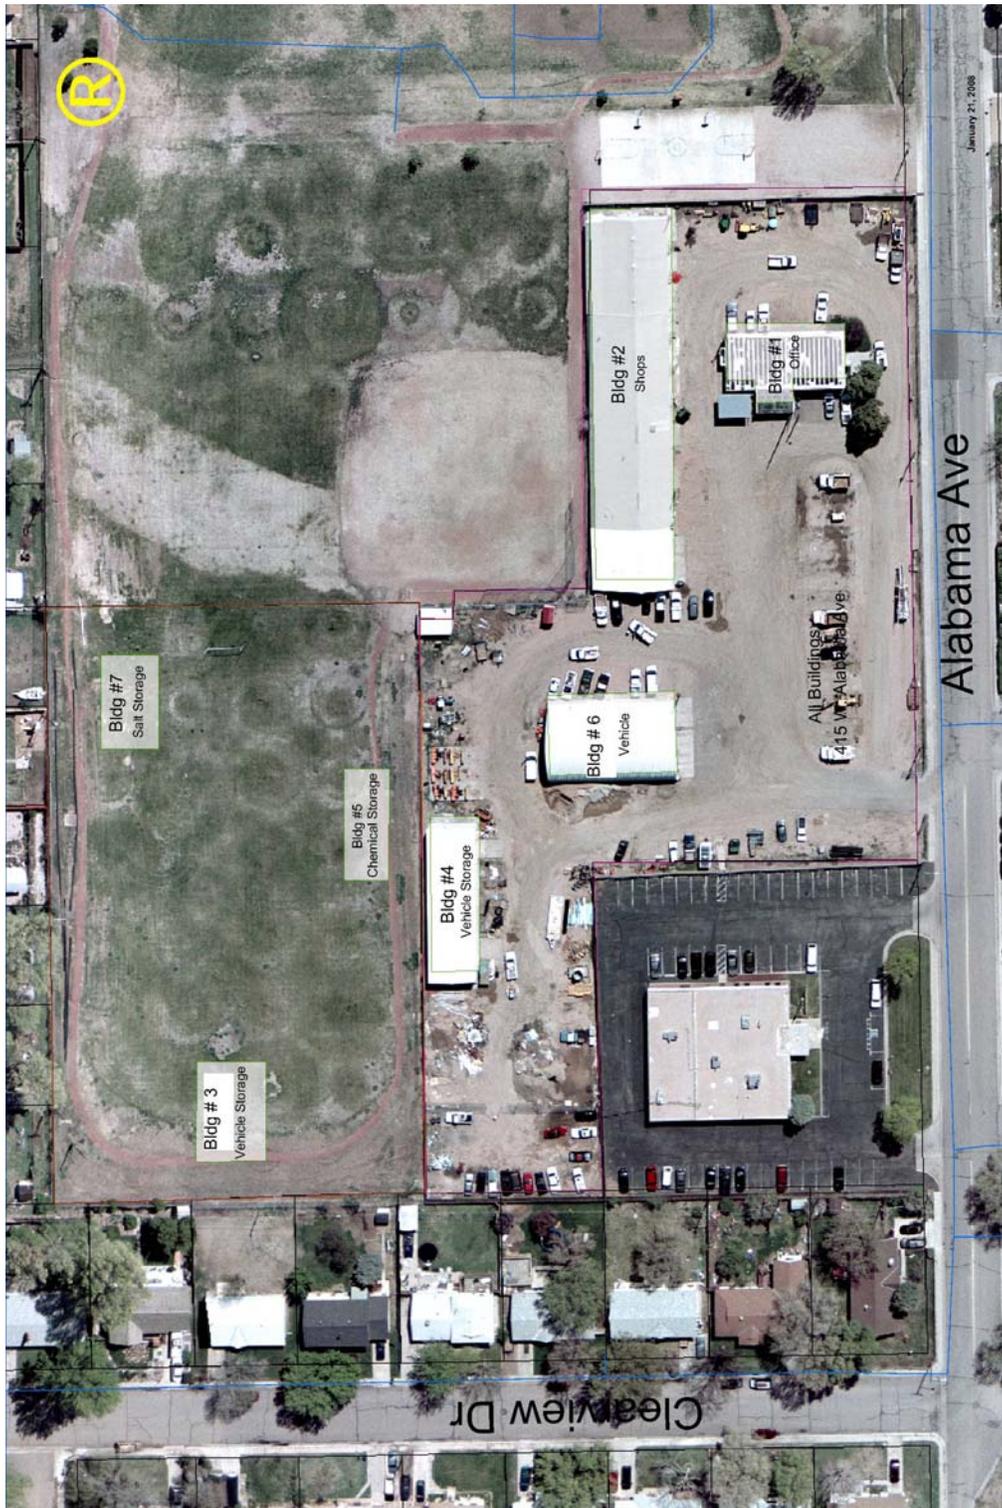
Exhibit 3.3- Water Department at 415 West Alabama.

The Water Department is located at 415 Alabama Avenue in Fountain. They are collocated with the Public Works Department, Streets and Parks Division, and the Facilities Maintenance Division. Exhibit 3.3 is a site plan of the Water department yard. The site is approximately 2.14 Acres with several buildings as follows:

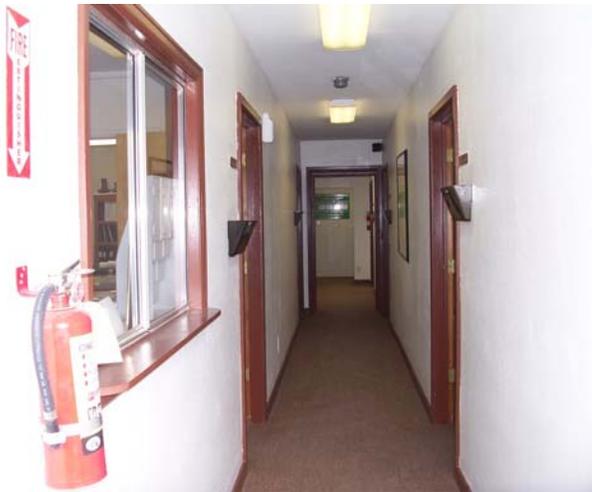
▲ *Main Entry Corridor with no Reception Lobby takes visitors directly into office spaces*

The staff occupies a concrete block and wood framed structure which it shares with the Streets and Parks Division of the Public Works Department. The building is approximately 3,037 sf, of which approximately 800 sf is occupied by the Public Works Department. Services such as break areas, restrooms, mechanical and janitorial spaces are common to both departments. Restrooms are also shared with the public. The age of the building could not be determined, but the structure including the roof is in poor condition requiring substantial repairs.

The building also has various accessibility and non building code compliant elements. There are no accessible and only one unisex toilet.

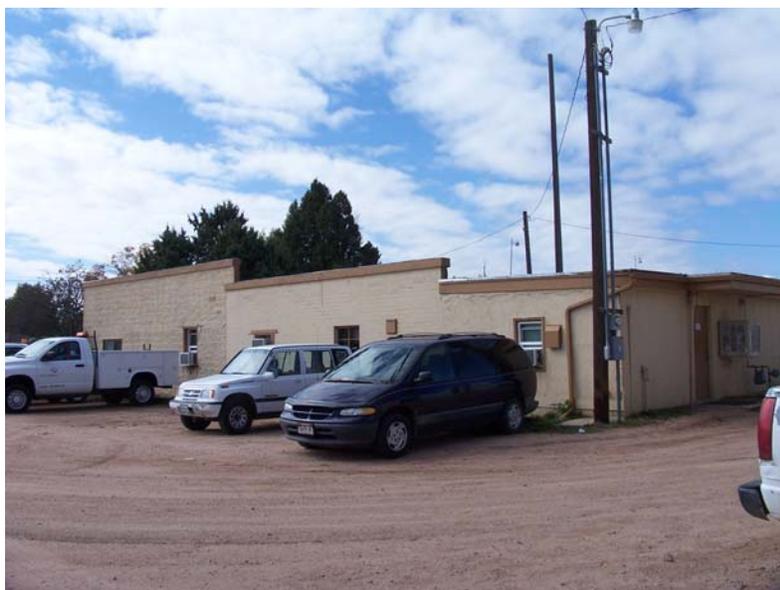
◀ *Water Department Building with several additions*

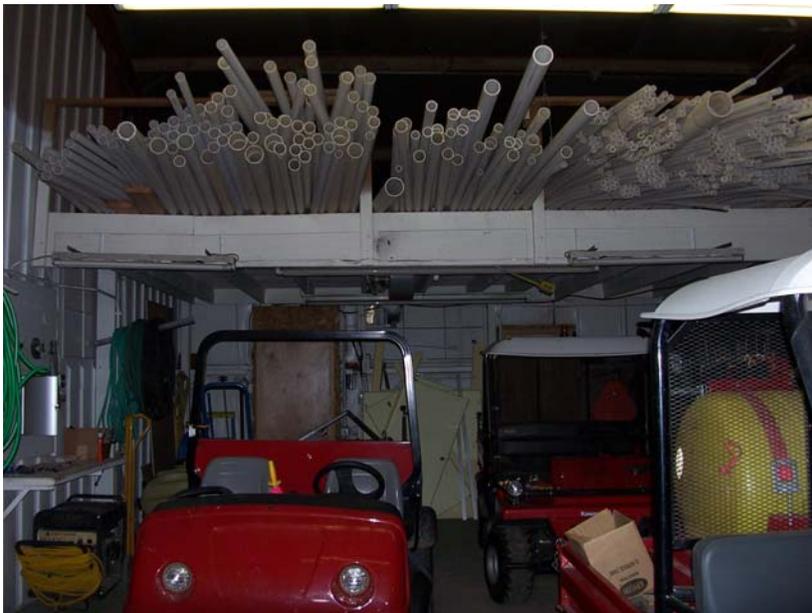
Exhibit 3.5 shows the building layout of the Water Department space in Shop/Storage building no. 2. This is a pre-engineered metal building with multiple bays occupied by the Water department, the Streets & Drainage, and Parks Division of the PWD. The Water Department occupies several bays and approximately 6,250 sf. in this building. The building is used for vehicle and equipment storage. The building has a mezzanine supported on wood posts. A visual inspection showed several missing posts, and structural deflections of the mezzanine support structure. The building is unsafe and in poor condition. It should be replaced as repairing it in its current condition is not cost effective.

◀ Sagging Mezzanine beams in Shop Building

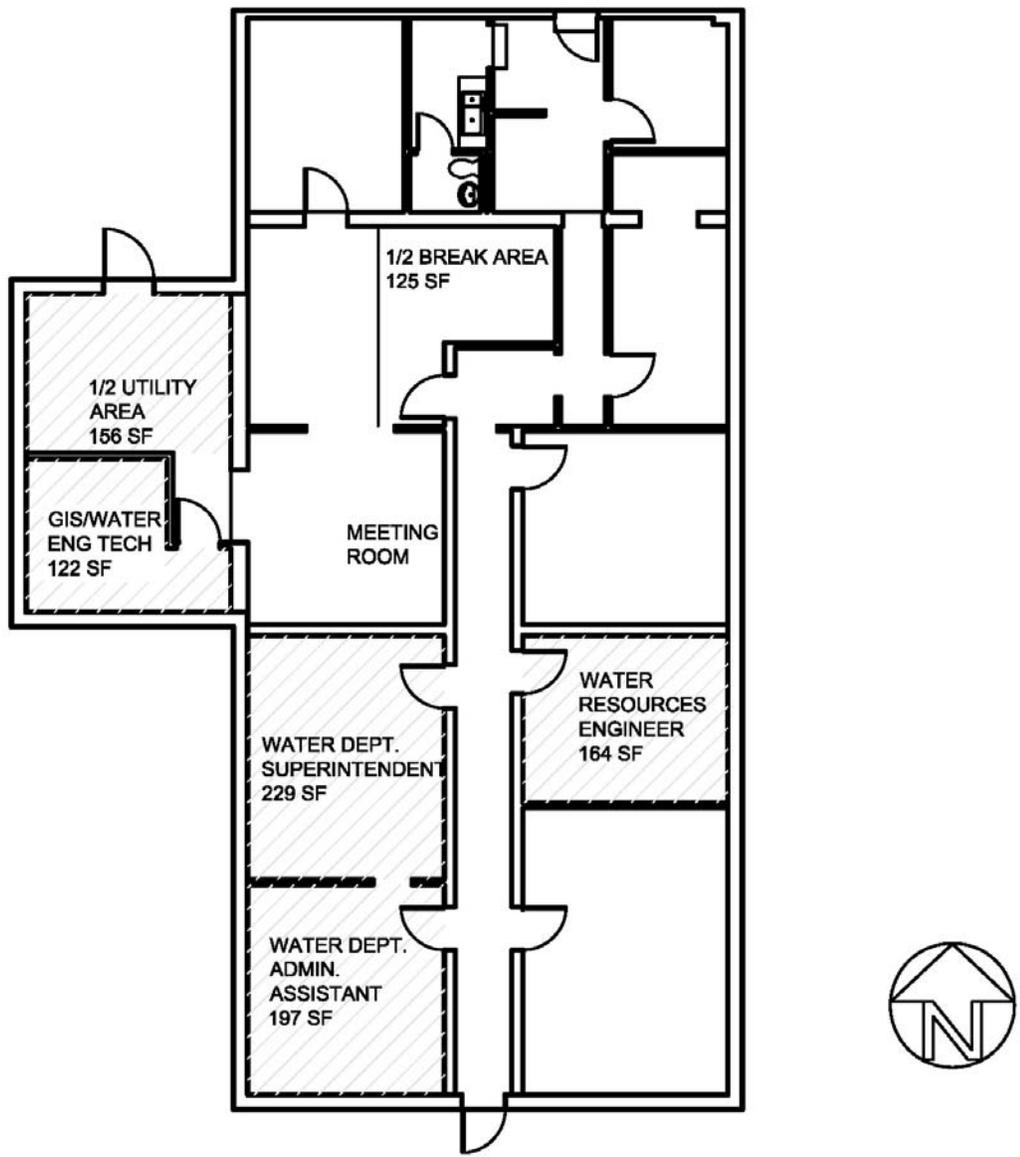
Exhibit 3.4- Floor Plan of Office Building No. 1.

FLOOR PLAN OF WATER DEPT. ADMINISTRATIVE BUILDING

The Water Resource Engineer has 164sf. of office space which is inadequate for this function. Provide a minimum of 200 sf. of office space.

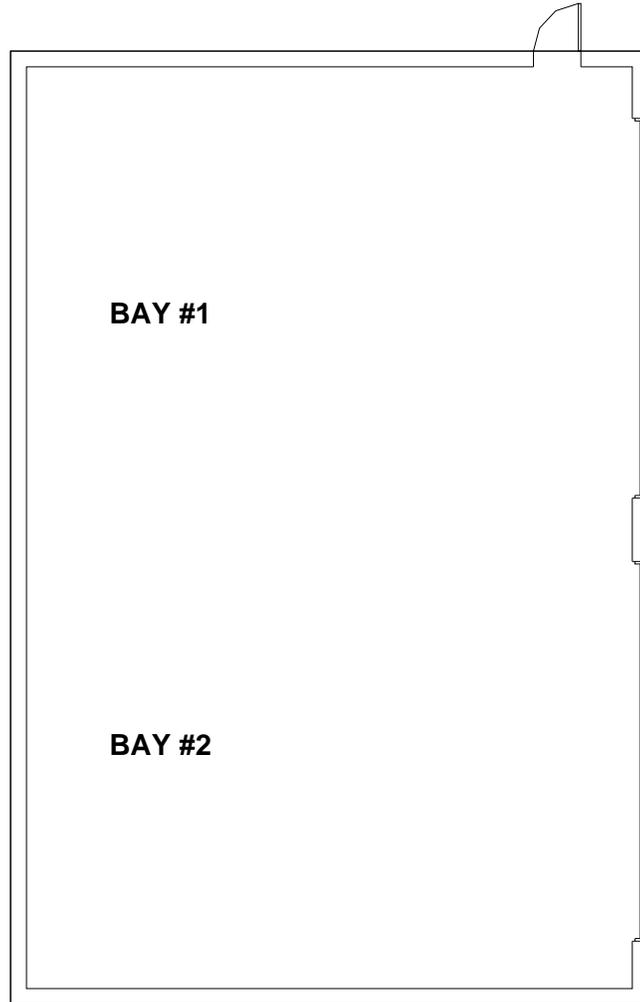
Exhibit 3.6- Floor Plan of Storage Building No. 3

Exhibit 3.6 shows the building layout of Storage building no. 3. This is a 2,400 sf. pre-engineered metal building with 2 bays. The building is used for vehicle storage. It was built in 2007 and is in good condition.

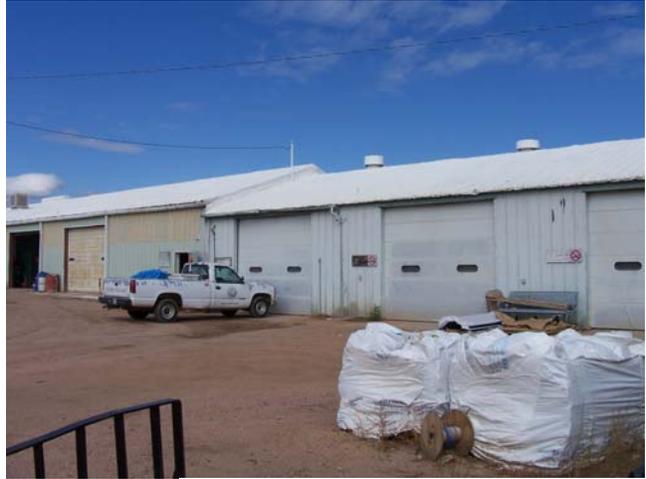
Shop Building

Exhibit 5.3 shows the building layout of the Streets Division space in Shop/Storage building no. 2. This is a pre-engineered metal building with multiple bays occupied by the Water department, the Streets & Drainage, and Parks Division of the PWD. The Streets & Drainage Division occupies approximately 3,100 sf. in this building. The building is used for vehicle and equipment storage. The building has a mezzanine supported on wood posts. A visual inspection showed several missing posts, and structural deflections of the mezzanine support structure. The building is unsafe and in poor condition. It should be replaced as repairing it in its current condition is not cost effective.

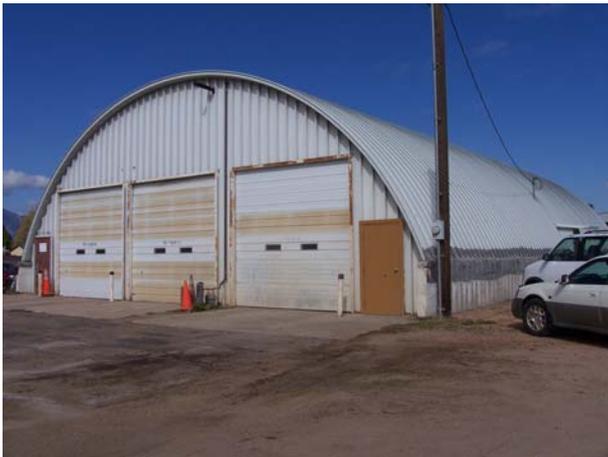
Storage Building No. 6- "Quanza Building"

Exhibit 5.4 is a floor plan of this building. It is a 4,250 sf large barrel shaped metal structure, also described as the Quanza hut building. Several large bays are used for vehicle storage. One bay was designed as a vehicle wash bay but is currently not being used as a wash bay. A portion of the building is used by Facilities and Maintenance Division of the PWD. The building is in poor condition with several deferred maintenance and repairs needed.

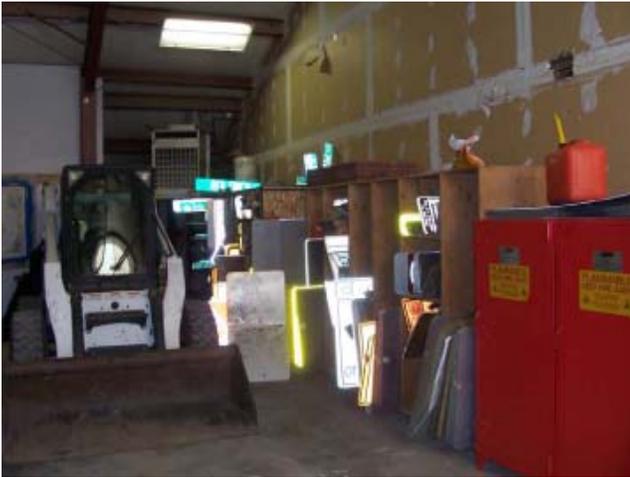
The Streets and Drainage Department does not have adequate covered storage for equipment. Expensive equipment are stored open to the elements, which lead to faster deterioration and hence, a shorter useful life. With additional covered parking, the equipment is protected and the life of these pieces of equipment can be extended.

◀ *Vehicle/Equipment Parking in Shop Building*

While some pieces of equipment need to be secured inside an enclosed structure, others can be stored in three sided storage barns.

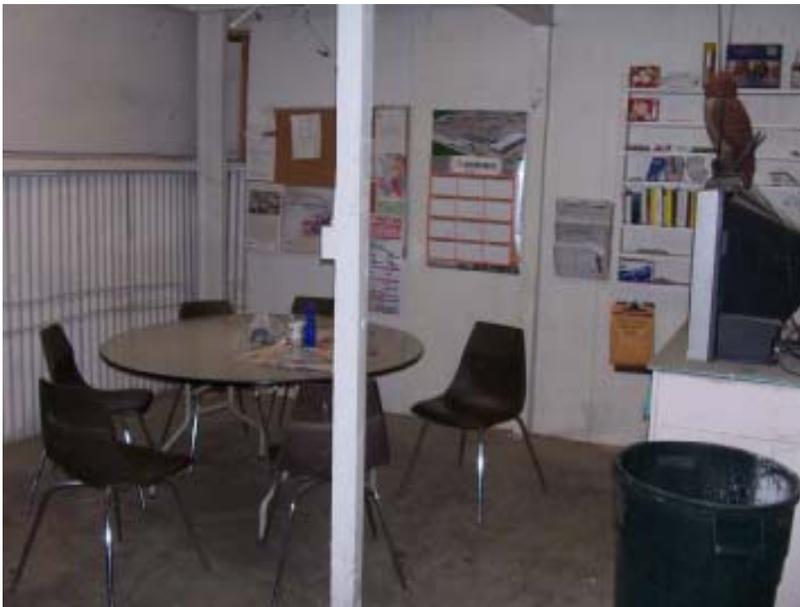
Break room The Parks division hires a large number of seasonal workers. The Parks employees use the Shop Break Area or the Office Building Area. Both spaces are inadequate for the number of people served especially when seasonal workers are added to the work force. Break rooms need to be sized appropriately to allow break room space for them. Using a ratio of 75 DGSF/FTE the break room can be sized for adequate space for seasonal workers.

◀ Shop Break Area

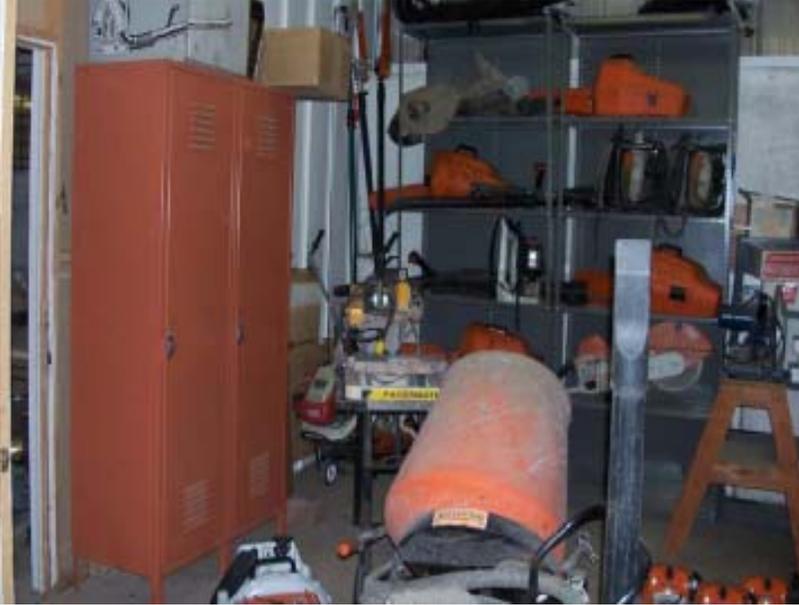
Chemical storage needs to be in a conditioned space. It is currently stored in an unconditioned container. In addition to covered parking for equipment and vehicles, workshop space is needed for maintaining parts and equipment.

◀ *Tools and Equipment Storage*

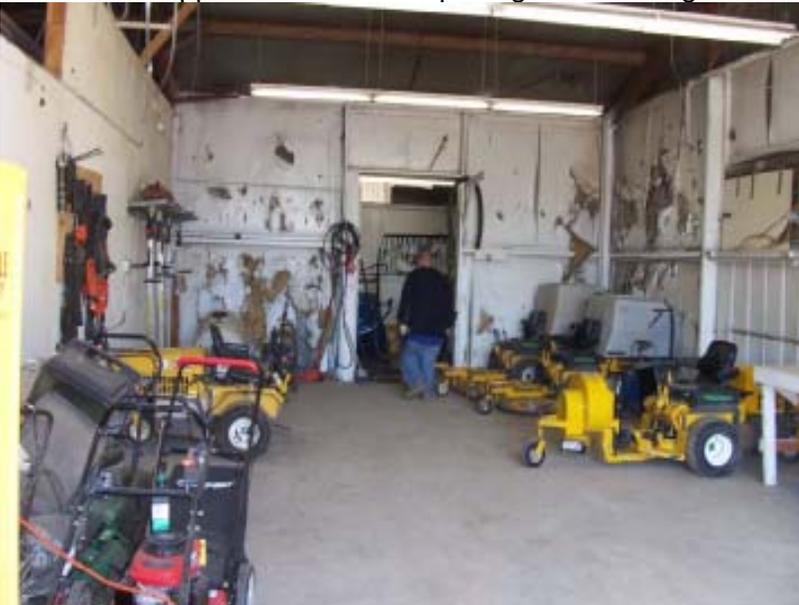
Exhibit 6.3 identifies current deficiencies. The Division needs additional equipment storage space. Based on existing designated gross square feet (DGSF) per equipment parked, future needs may be calculated at the rate of 250 DGSF/vehicle.

◀ *Small Equipment Parking*

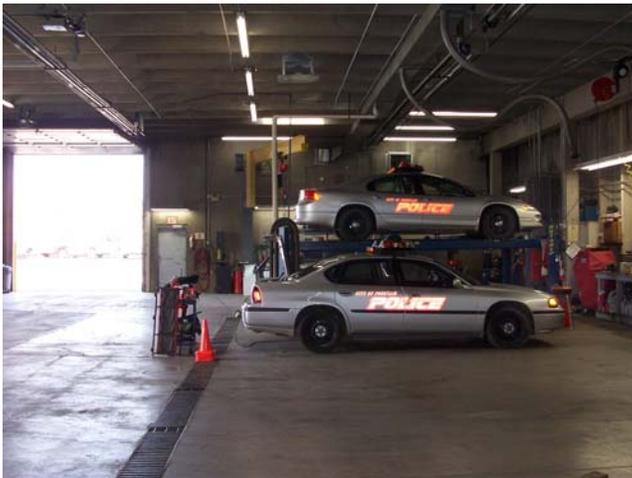
The Fleet Services is co located with the Electric Department at 6745 Southmoor Dr. The building is 6,800 sf. The building is a precast concrete and added on to the existing Electric Department building in 1986. The building is roughly divided into five bays as shown in Exhibit 7.2.

◀Fleet Repair Bays in Shop Building No. 1

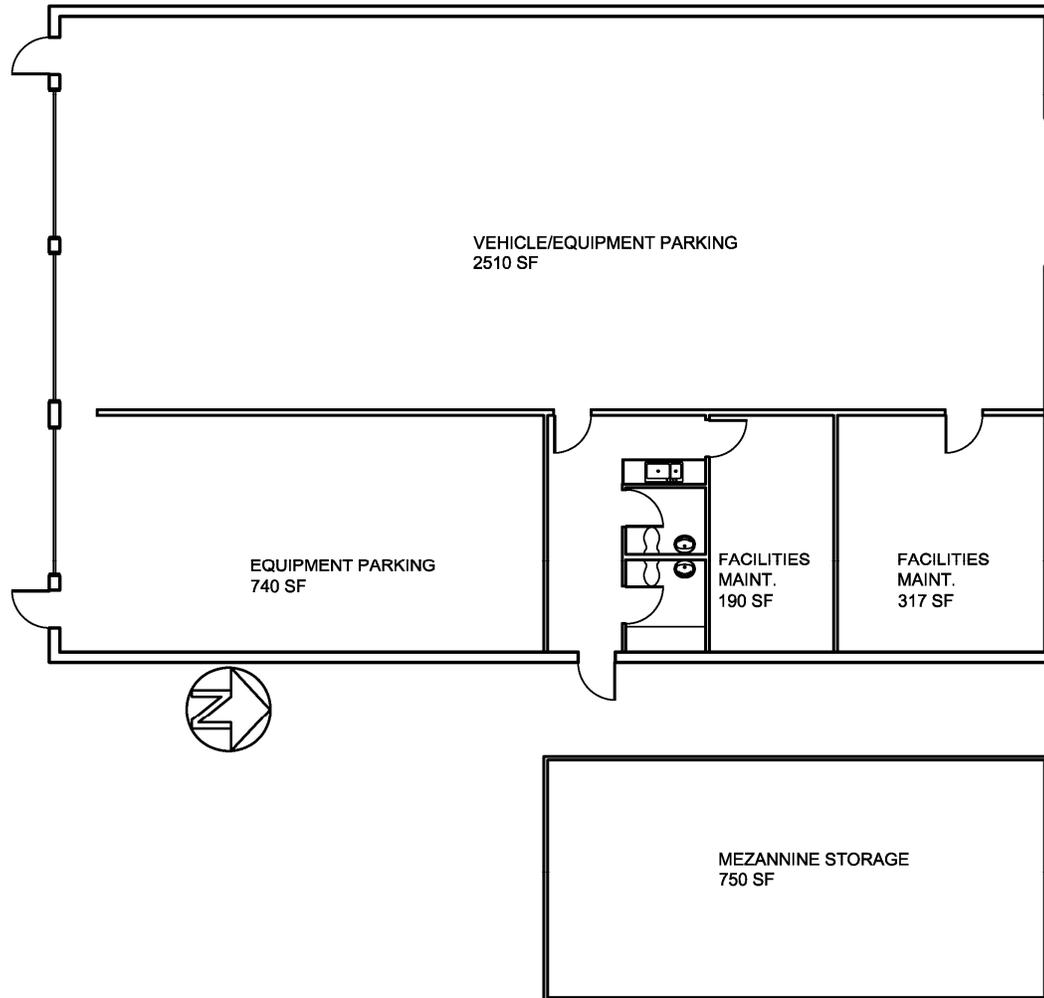
Exhibit 8.2- Floor Plan of Facilities Maintenance space in Building No. 6

Exhibit 8.2 is a floor plan of this building. It is a 4,250 sf large barrel shaped metal structure, also described as the Quanza hut building. Several large bays are used for vehicle storage by Streets and drainage. Facilities maintenance occupies approximately 500sf of space in the building.
