U.S. Highway 85 Corridor

Conditions Survey

Fountain, Colorado

Surveyed in September / October 2007 and April 2008

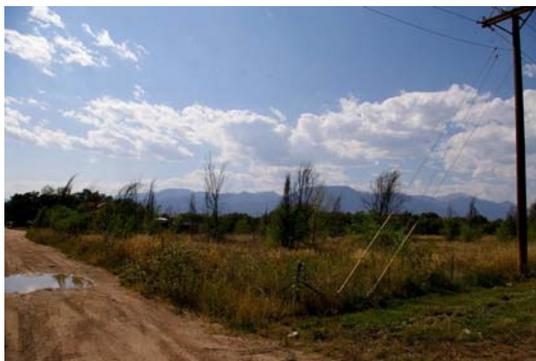
High Service Demands or Underutilized Sites (Condition K5) considers two different conditions that can impact the “welfare” of an Area. Sites exhibiting “health, safety, or welfare factors requiring high levels of municipal services” including areas of

Areas characterized by “substantial physical underutilization or vacancy of sites, buildings, or other improvements” including vacant lots, parcels with vacant structures, or parcels for which the value of its improvement is disproportionately small relative to the land value, are also considered to have a “blighting” impact. The Survey Area has a number of parcels of vacant land which qualify as underutilized, as well as several buildings which are partially vacant (at least 20 percent), completely vacant or even abandoned. Vacant land can be found scattered throughout the Area, including in the vicinity of Exit 132.
